Manual Supplement

Manual Title: Print Date: Revision/Date: 752A May 1983 1, 4/84 Supplement Issue: Issue Date:

752A Manual Supplement

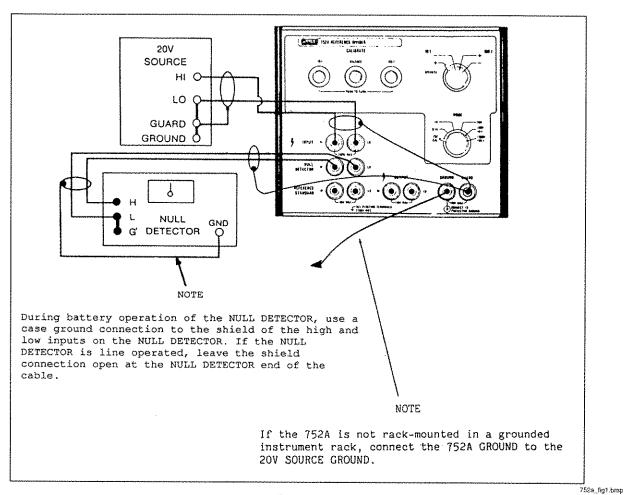
On page 2-4, replace Figure 2-2, with Figure 1.

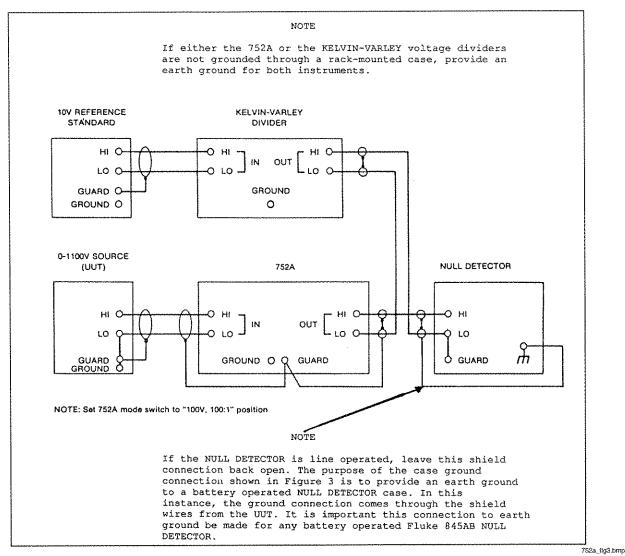
Figure 3.

If the NULL DETECTOR is line operated, leave this shield connection back open. The purpose of the case ground connection shown in Figure 3 is to provide an earth ground to a battery operated NULL DETECTOR case. In this instance, the ground connection comes through the shield wires from the UUT. It is important this connection to earth ground be made for any battery operated Fluke 845AB NULL DETECTOR.

On page 2-6, replace Figures 2-4 and 2-5 with Figures 2 and 3 respectively.

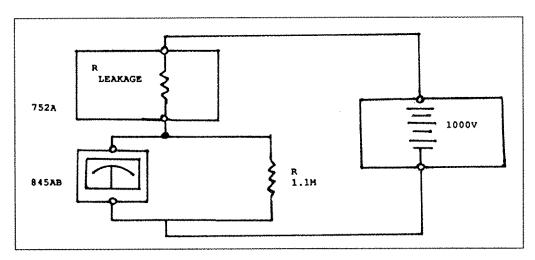
Figure 4. Equipment Connections For Leakage Resistance Test

4-31b. Perform the following procedure to prevent ratio errors caused by leakage. It is recommeded that this procedure be done annually. Refer to Figure 4 for equipment connections.

1. Place the 752A on a sheet of dielectric. Use teflon insulated wires to connect the 1000V source to the 752A and 845AB. Connect a 1.1 megohm resistor across the 845AB input terminals to bring the input resistance to 1 megohm.

- 2. Connect the 1000V source to the 752A Input High binding post.
- 3. Connect the 845AB positive (+) input to the 752A Guard binding post.
- 4. Connect the 845AB negative (-) input to the 1000V source negative output binding post.
- 5. Set the 752A switches a follows:

- 6. Apply 1000V from the source.
- 7. The 845AB reading must be 0.5 mV or less to pass.
- 8. Set the source to standby and change the 845AB positive input lead from the 752A Guard binding post to the 752A Ground binding post.
- 9. Repeat steps 6 and 7.

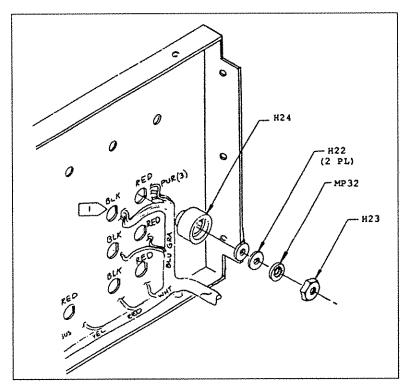
Add: H22IWASHER,FLAT,BRASS,#8,0.32 THK l631606l86928l5714-162-32l20 H23INUT,HEX,BR,8-32 l631614l73734l631614 l10 H24IB-P-WASHER l606293l89536l606293 l10

On page 5-5, Figure 5-1, add H22, H23, and H24 as shown in Figure 5.

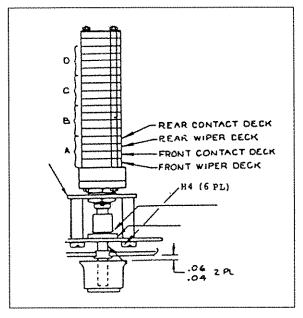
On page 5-5, Figure 5-1, change the view of H4 as shown in Figure 6.

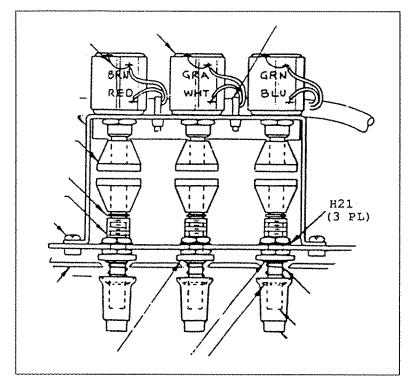
Add: H21|WASHER,LOCK,INTERNAL|129957|78189|1220-05|1

On page 5-5, Figure 5-1, add H21 as shown in Figure 7.
